Observations of water levels in Beaverhill Lake in 2017

By: Sara Pearce Meijerink
Assistant Biologist
Beaverhill Bird Observatory

November 10, 2017

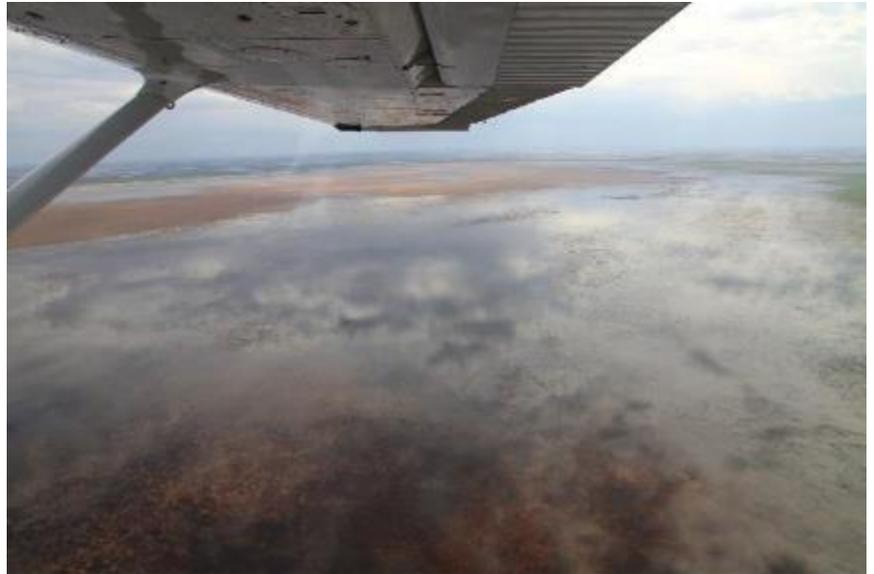
On October 7th, pilot Paul Ferron posted a photo (Left) on social media showing that open water was still present in the Beaverhill Lake bed.

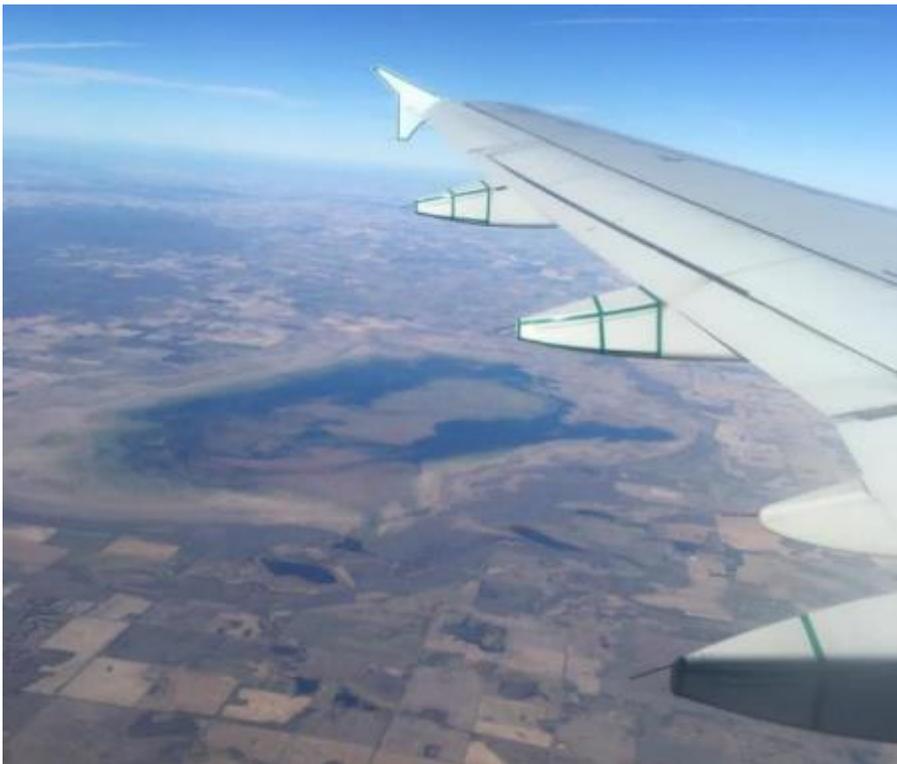
Then on May 10th, the BBO staff flew an aerial survey of Beaverhill Lake to better document the extent of the water and estimated that 70% of the historical lakebed was flooded with 50% containing open water (BBO 2017).

*Photo on Right:
Beaverhill Lake from the East
shore looking South.
Photo Credit: Sara Pearce
Meijerink*

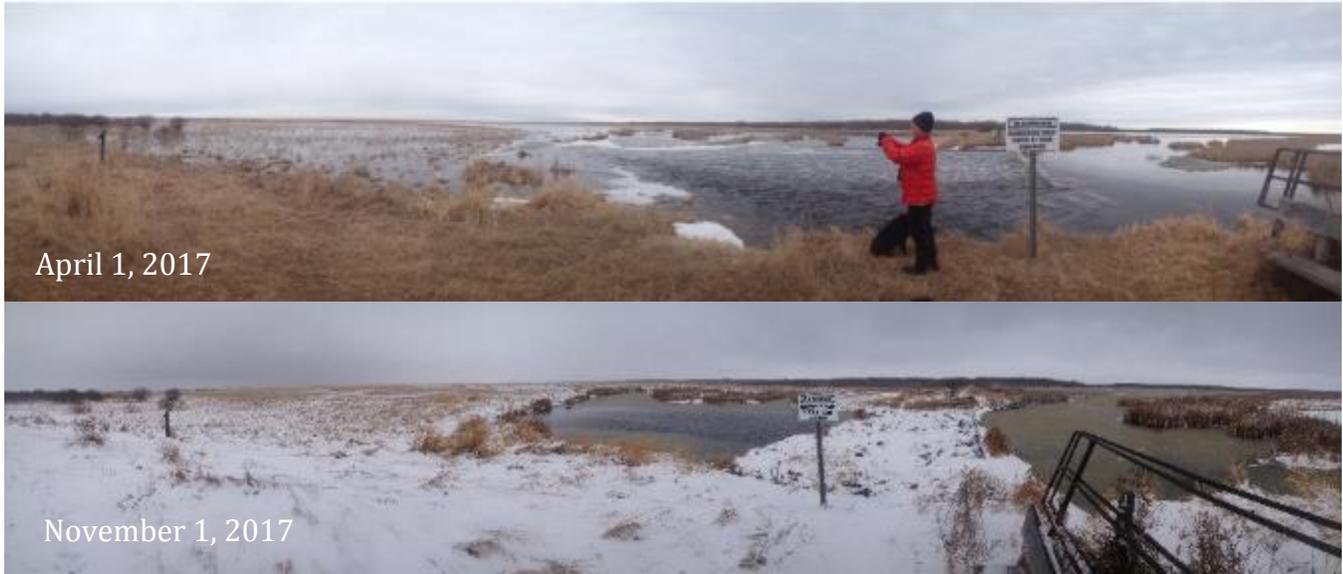
Throughout the spring, summer and fall seasons, I photographed the water levels at the weir between Lister and Beaverhill Lakes to document the seasonal changes.

See Appendix 1 for the full photographic documentation.

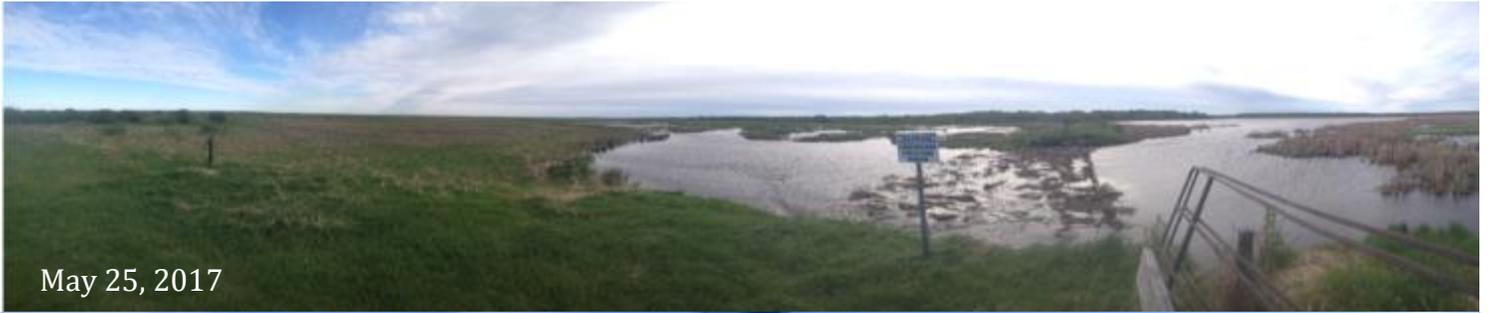
May 25, 2017

The following are photos taken from April 1st until November 1st, 2017. They were taken in 7 to 15 day intervals.
